# UAS MONITORING OF STREAM RESTORATIONS

Jakub Langhammer, Theodora Lendzioch, Jakub Šulc

Charles University, Faculty of Science, Dept. of Physical Geography and Geoecology

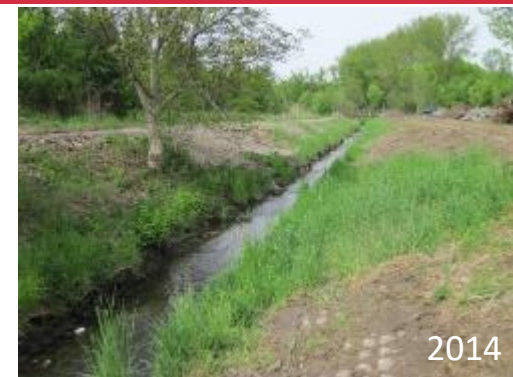
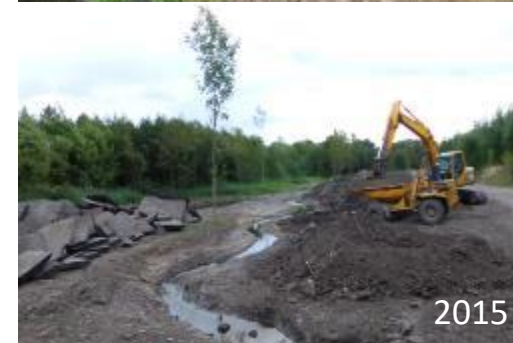
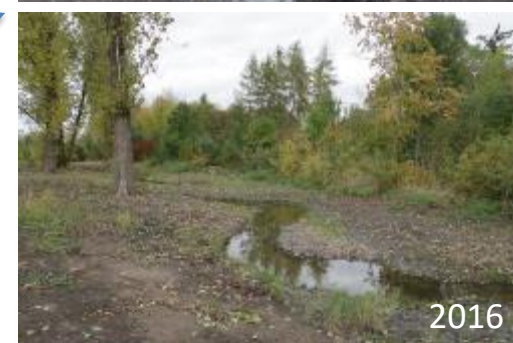
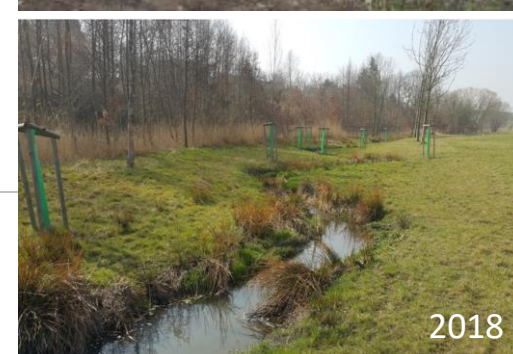
2014

2015

2016

2018

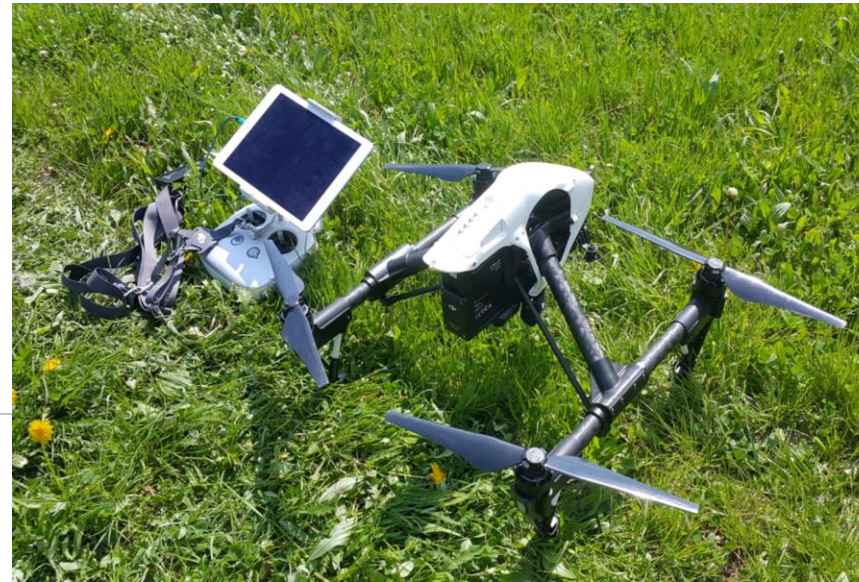
- **Monitoring campaigns**
  - Start – HOS 2015/09, ROK 2016/09, LIP 2018/09
  - Monitoring of restored stream segments
  - Frequency - 4 campaigns per year + after flood events
  - Segment length 1-2 km, width 200-400 m
- **Imaging platforms**
  - DJI Inspire 1 Pro
    - Zenmuse X5 16 MPx, lens Zuiko Digital 12 mm
  - Mavic 2 Pro
    - Hasselblad L1D-20c, 20 MPx
- **Image acquisition**
  - Altitude 60 m
  - Resolution GSD = 2 cm
  - 80% frontlap/sidelap
  - Pre-planned routes
  - 200-400 images per campaign

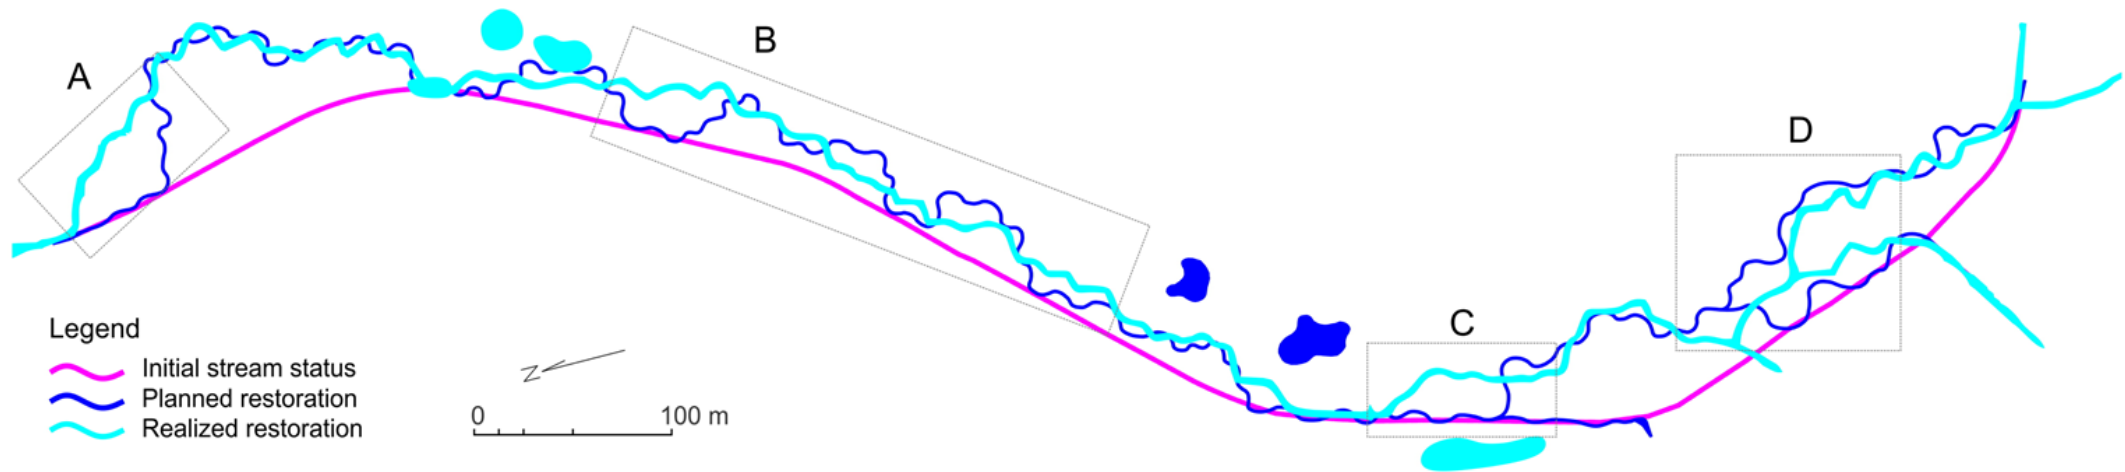
- ... Substantial improvement from the initial status
- ... Significant discrepancy of the restoration from the approved plans

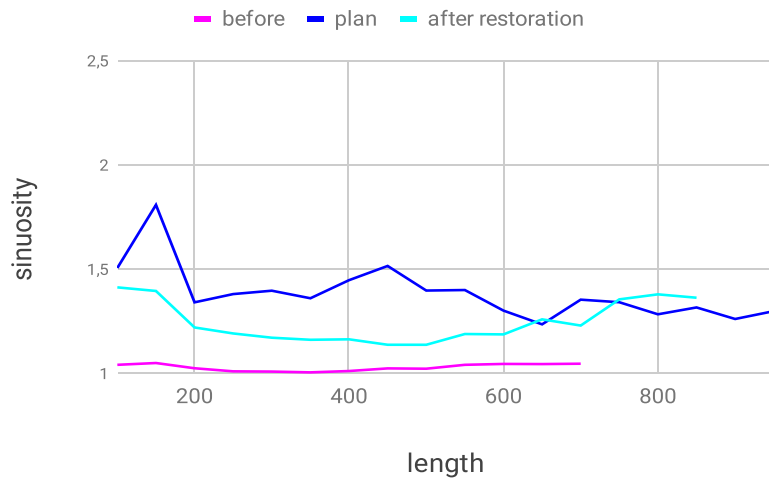
Hostavicky brook

- Differences in stream sinuosity
- Calculation in 50 m long segments
- HOS, ROK – almost straight prior restoration
- LIP – straight segments with large bends
- ROK – largest discrepancies between the plan and realized restoration
- LIP – closest match but lowest change in stream length

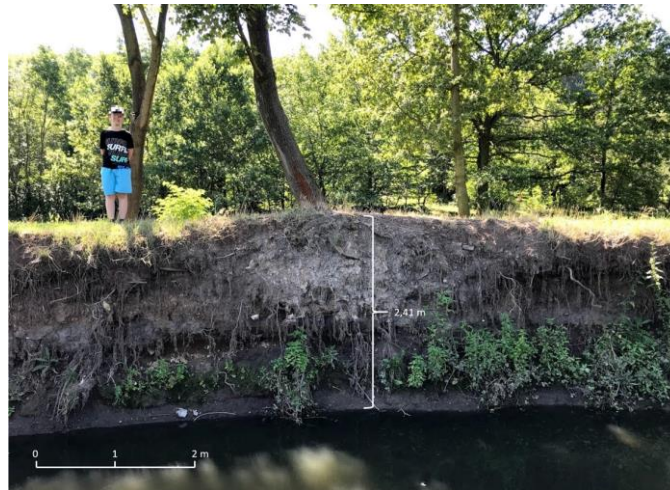
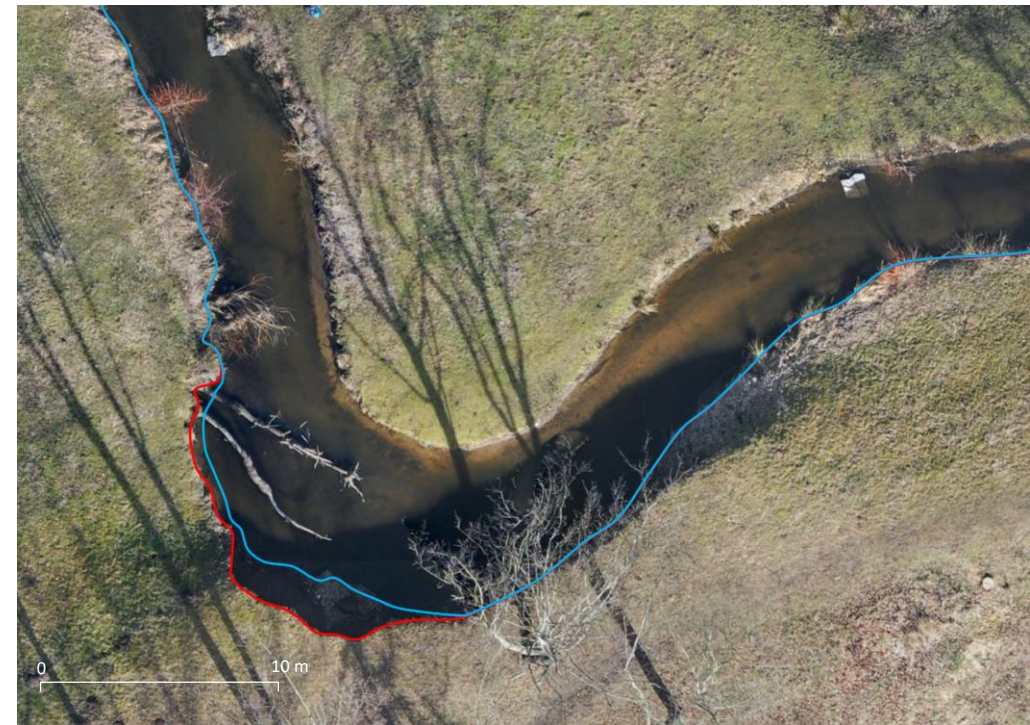
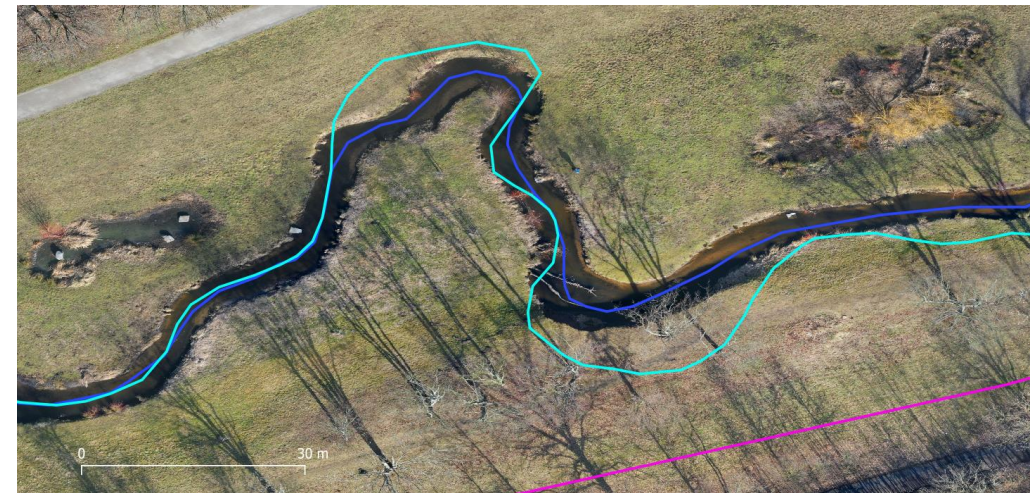
- **Rokytká brook**

- Extensive bank erosion
- Erosion initiated in meander, built with different parameters than planned
- Unstabilized bank
- Continuous cutbank
- No substantial flood events
- Rapid progress
- 2 years
  - 2,4 m height
  - 2,5 meters depth
  - 8 meters width

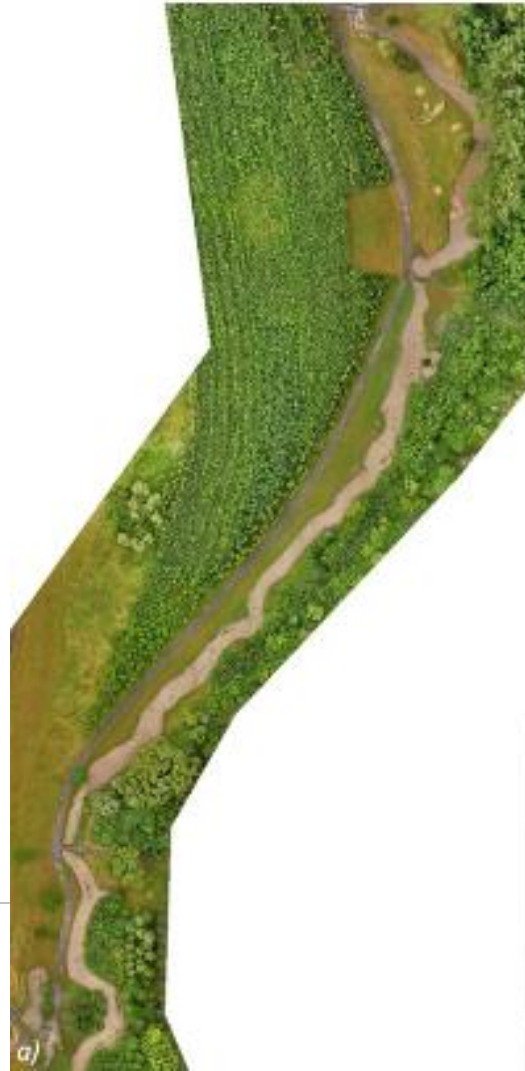
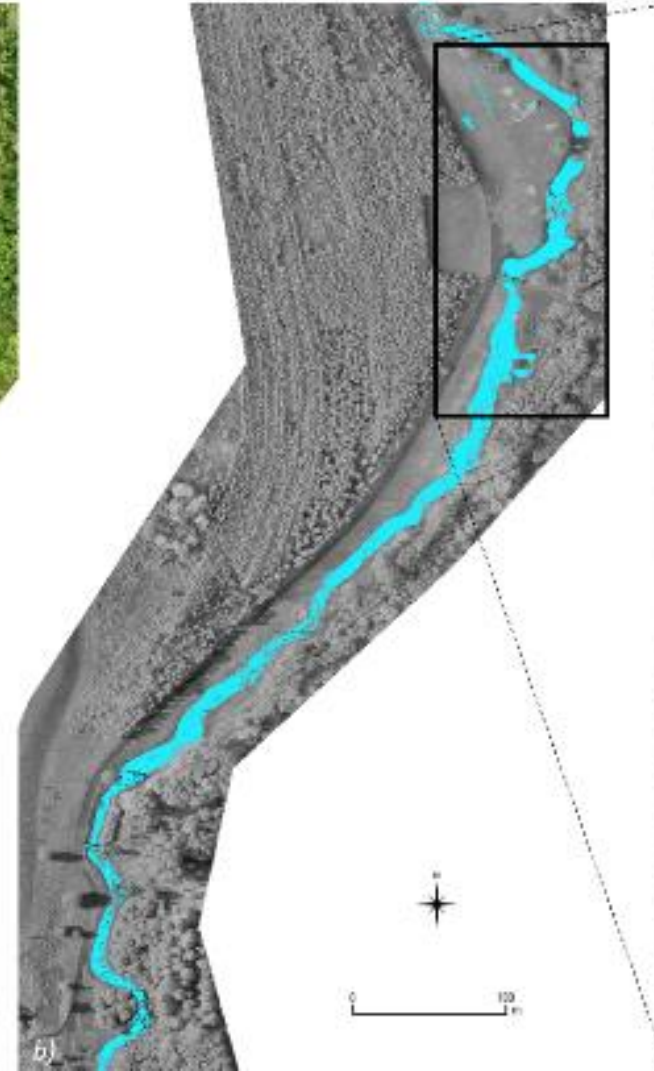
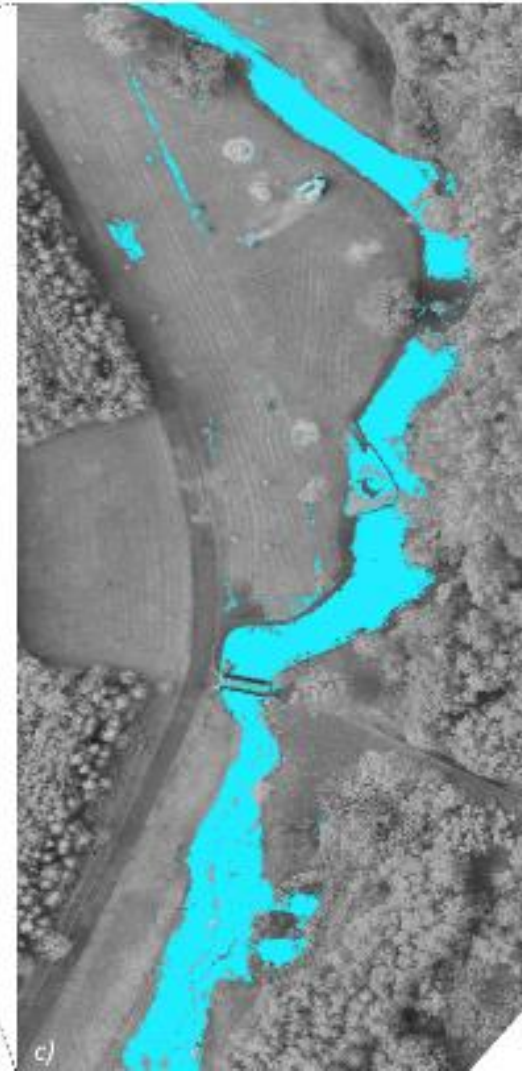
- Finding the balance between the needs of flood protection in urban area and stream restoration
  - Detection of flood spill during a summer storm flood
  - Hostavický brook
    - 2018-06-30
    - Approx 5 year flood
  - Google EarthEngine Random Forests classification
- Flood spill is not constrained by artificial barriers or dikes
- Flood spill not exceeding the riparian zone

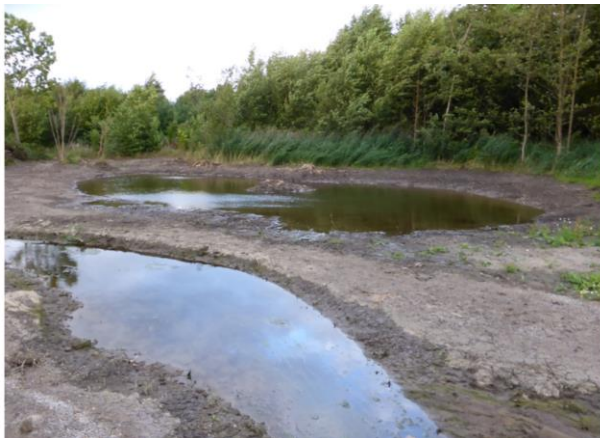
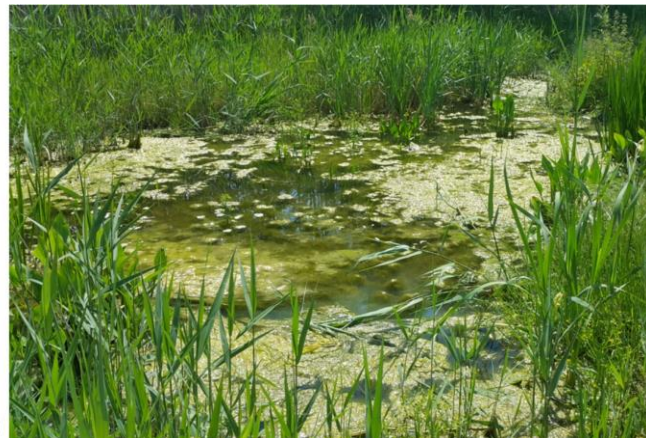
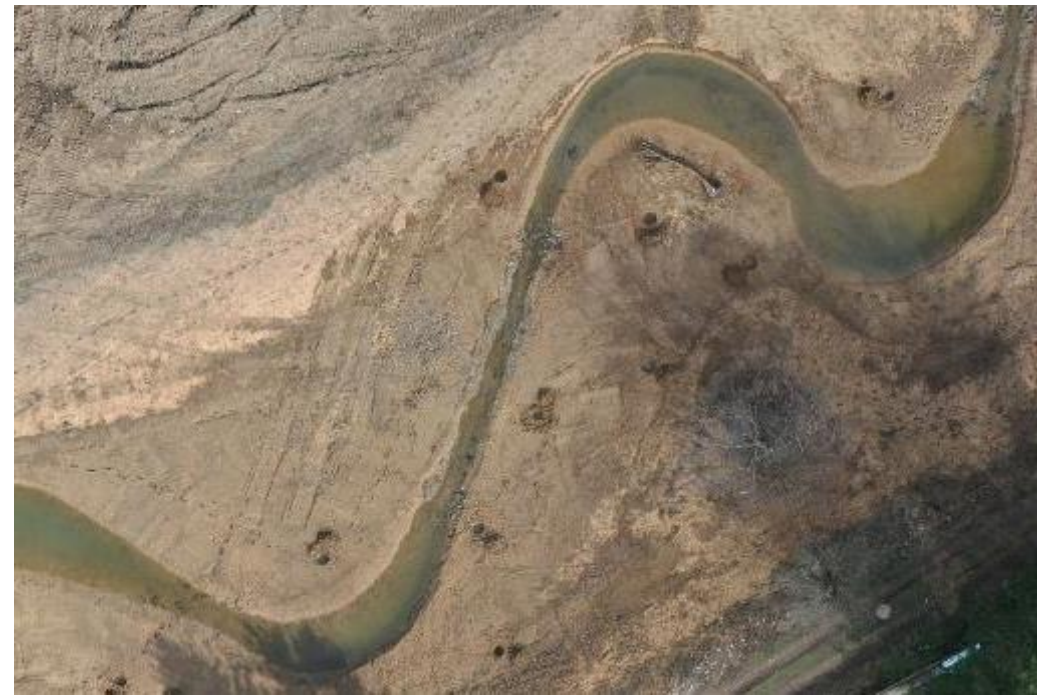
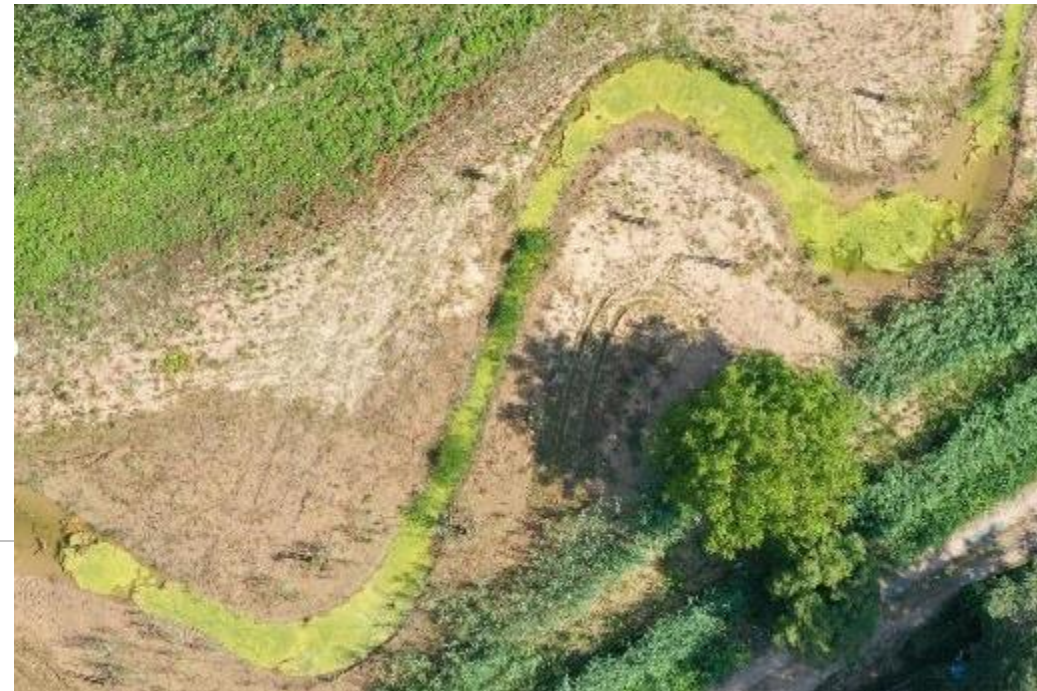
## Eutrophication in ponds and cut-off meanders

- Insufficient drainage

- Extensive pollution by nutrients (N, P)
- Extensive water abstraction
- Improperly set designed low flow values (environmental flow)
- Improper design of restoration elements

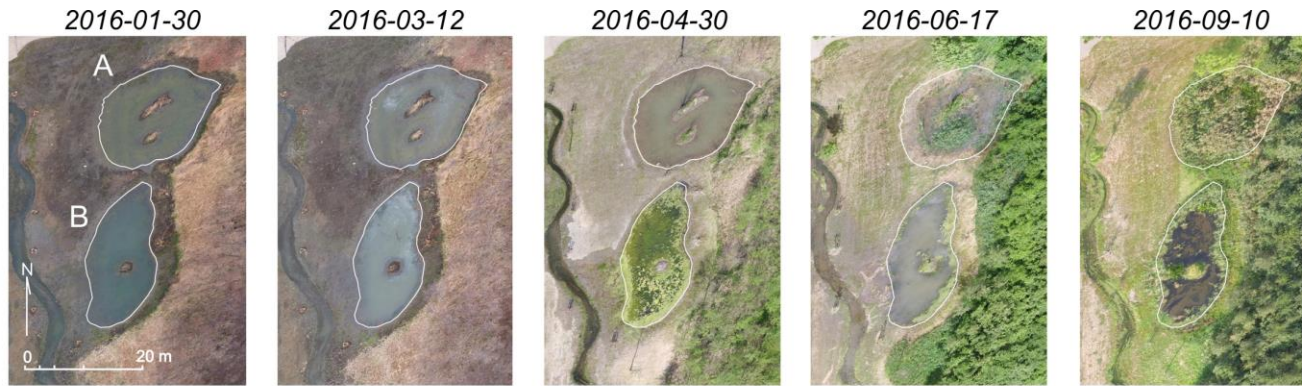
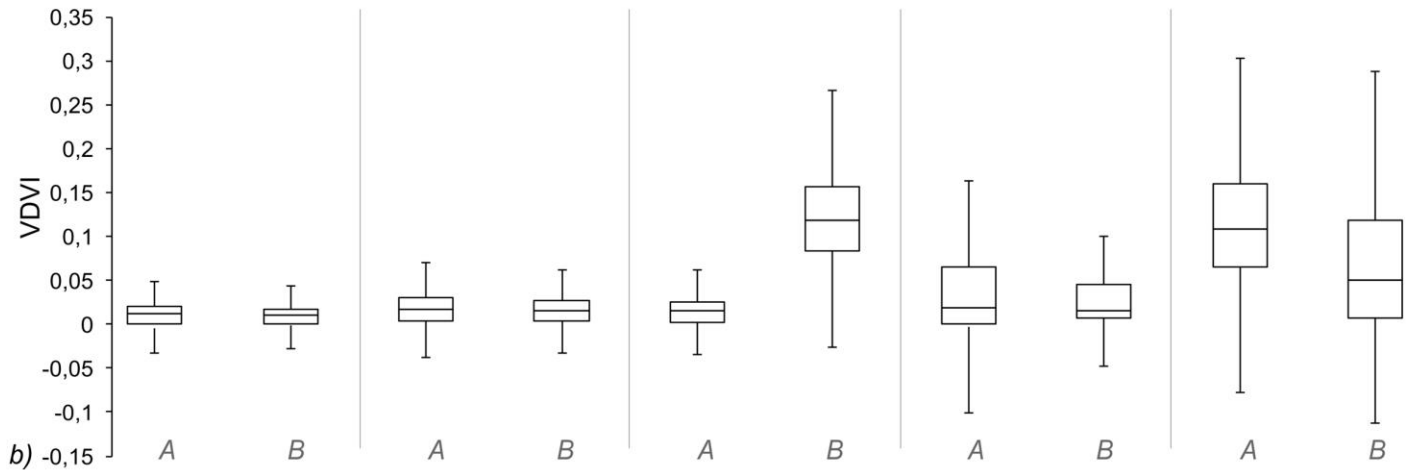
$$VDVI = (2 \times G - R - B) / (2 \times G + R + B)$$

*VDVI index calculated under the mask of ponds – Correctly reflecting intensity of eutrophication*

*- Quantitative measure of the dynamics of eutrophication processes*

eutrophication in newly built ponds

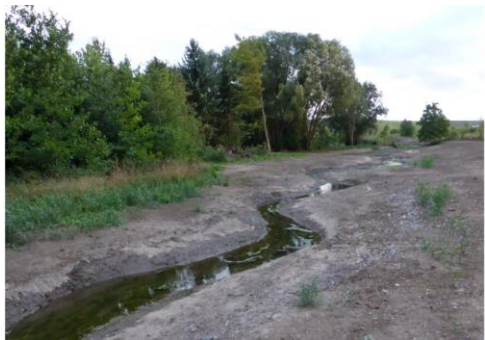
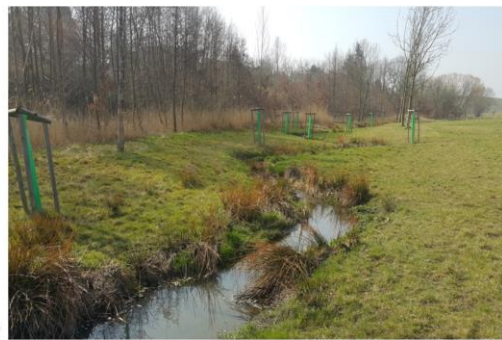
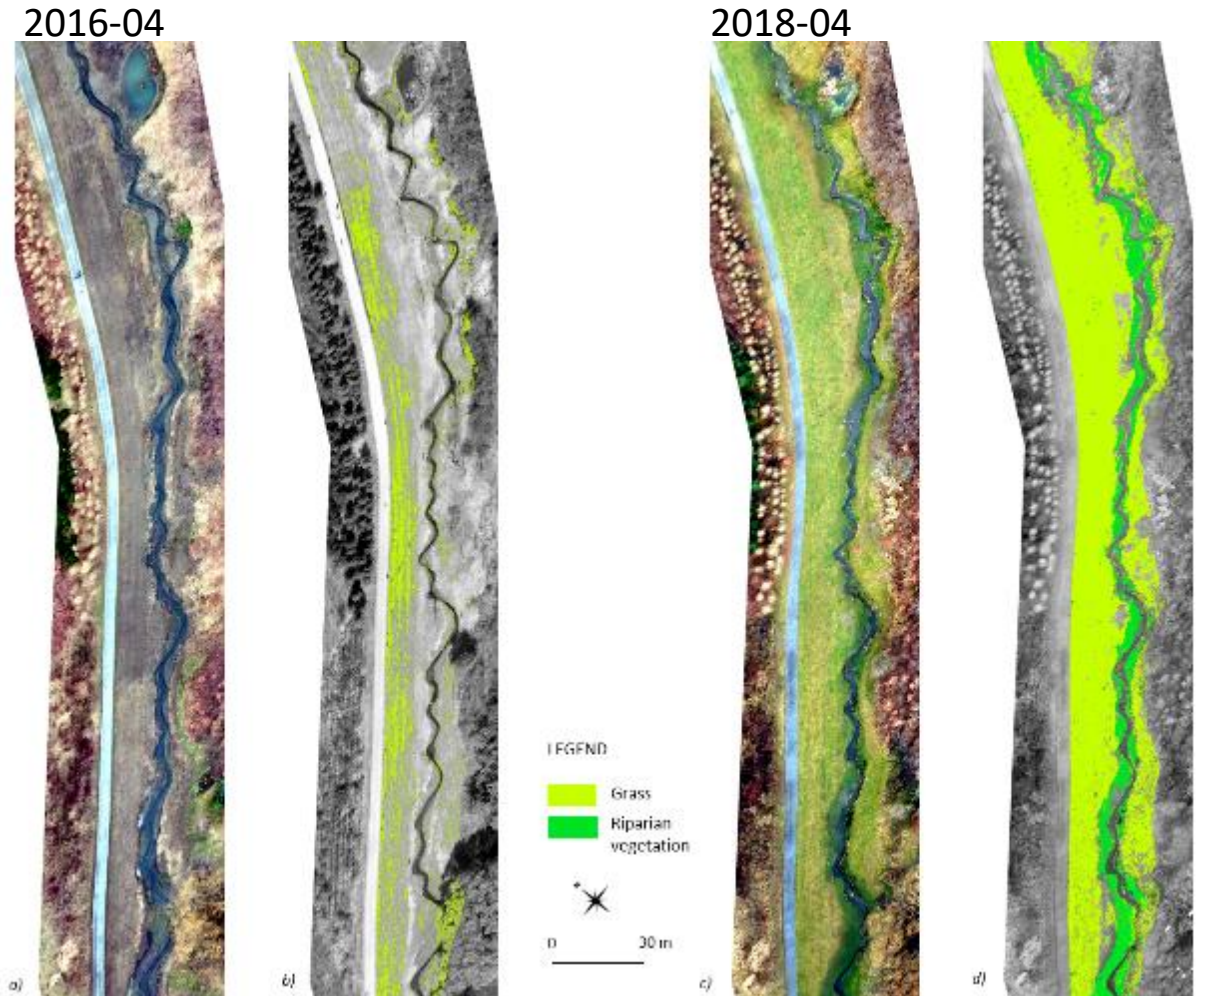
- Vegetation succession
- Bank stabilization
- Stream habitat development
  - Extent of grassing
  - Diversity of riparian vegetation
- Google EarthEngine Random Forests classification under mask of riparian zone
- ... same technique used for detection of riparian shading
